# Case Study 15

## Steel Mill Coke Gas Desulfurization Filtration Upgrade

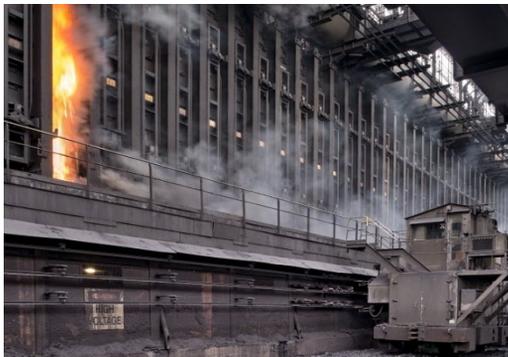
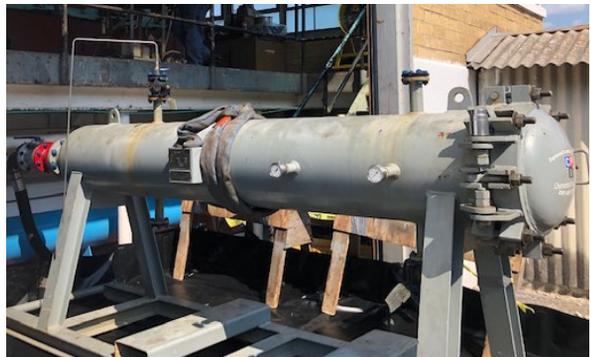
To better understand their issues we witnessed a filter change. The current filter design was a very tall, vertically oriented filter housing that required a platform to access the elements. The elements were depth type, very long DOE style with no gaskets. Upon opening the filter closure, the elements were not immediately visible as the vessel appeared to be packed full of solid particles with only the upper portion of the top seal springs visible. The operator performed an arduous task of removing the springs and rocking the elements to loosen them enough to be removed by a lift hoist. Autopsy of the elements indicated they were all surface loading with bypass occurring at the bottom seal. Our mission was now clear: Improve seal integrity & operator ergonomics. We provided a horizontal rental filter with pleated, O-ring sealed elements. The new design was a great improvement with change out time reduced by 75% and elimination of contamination bypass. The rental filter is still there except now they own it!
